**STRESS CORROSION TESTING OF SA 455 CARBON STEEL IN
METH-REACTION INHIBITED AGRICULTURAL AMMONIA SOLUTIONS**

PREPARED FOR
IOWA DEPARTMENT OF TRANSPORTATION
DES MOINES, IOWA

PREPARED BY
CC TECHNOLOGIES LABORATORIES, INC.
MICHEL P. H. BRONGERS, P.E.
WILLIAM KOVACS III
JOHN A. BEAVERS, Ph.D.
ARUN K. AGRAWAL, Ph.D.

AUGUST 30, 2006

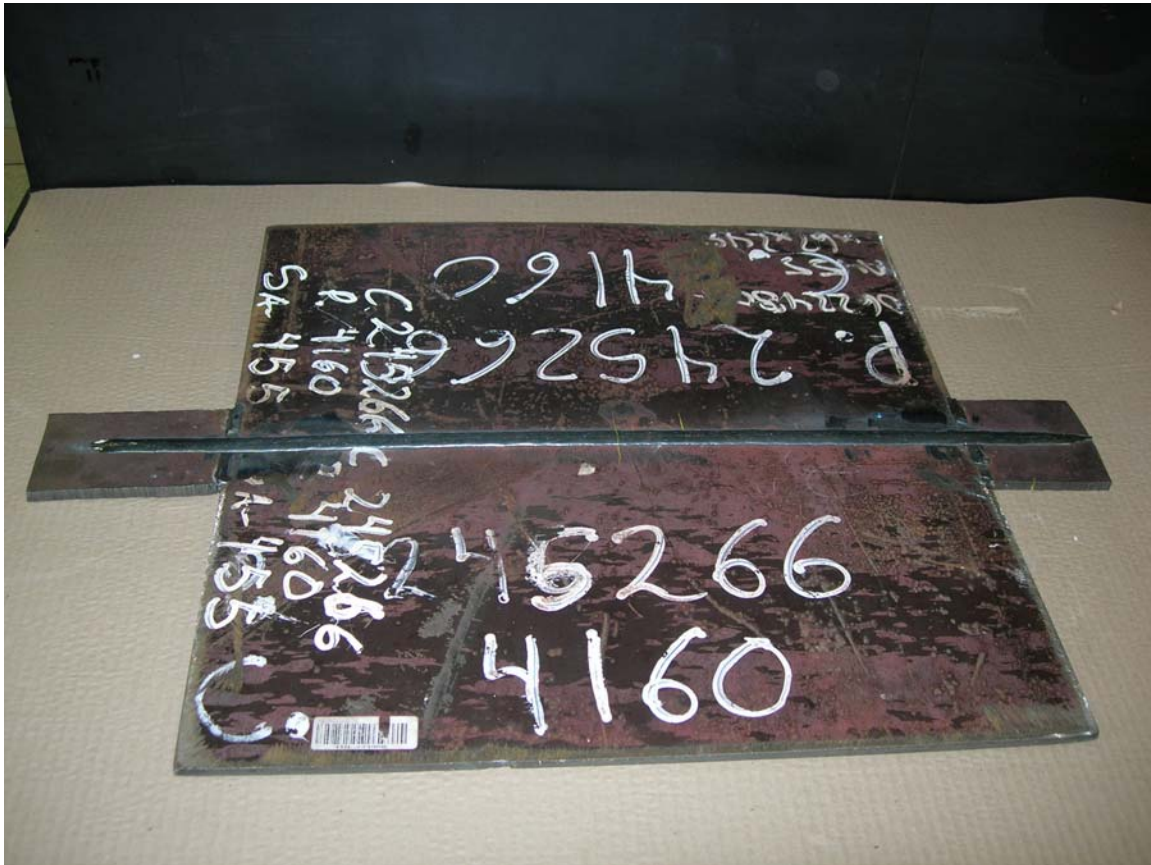
Figure 1. Welded SA 455 plate before specimen manufacture.

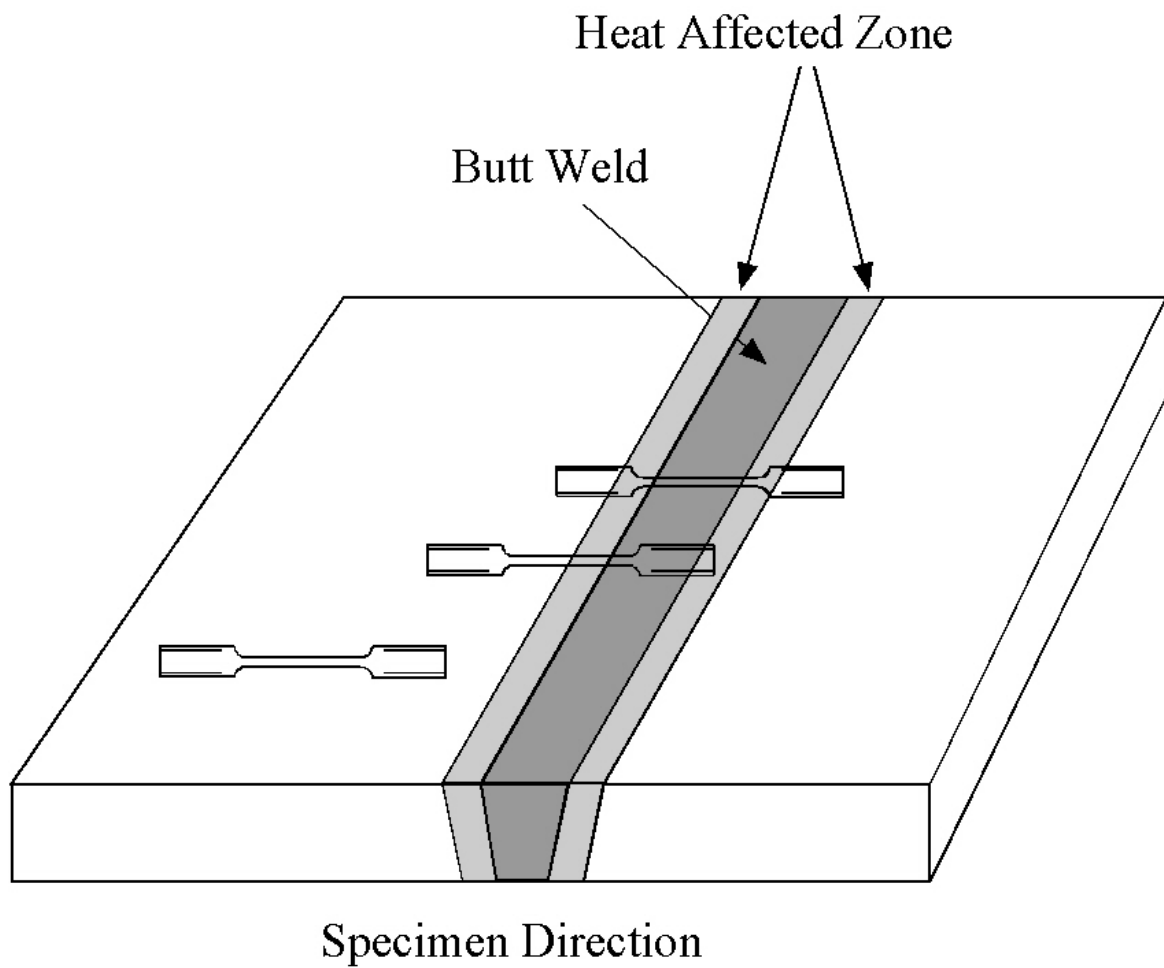
Figure 2. Sketch of welded plate for specimen fabrication.

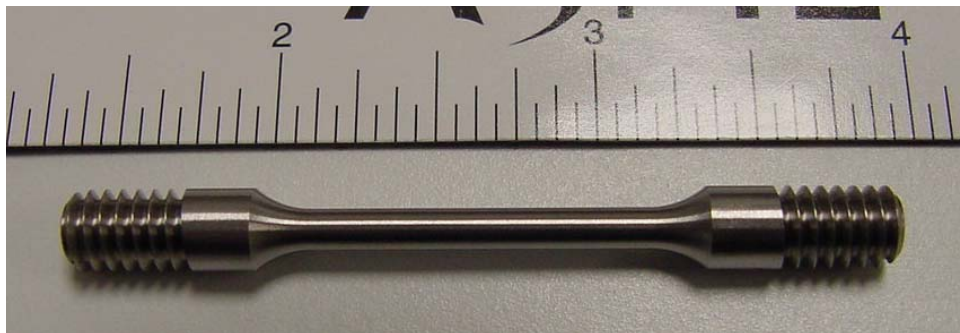
Figure 3. Typical test specimen.

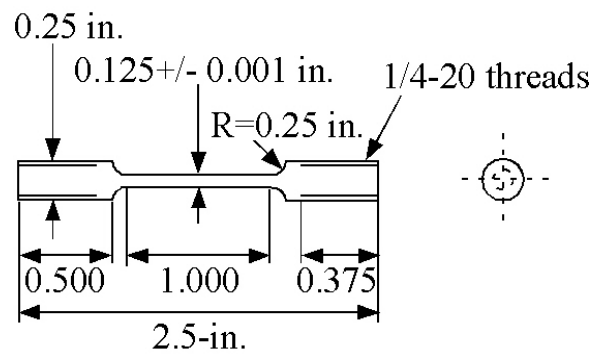
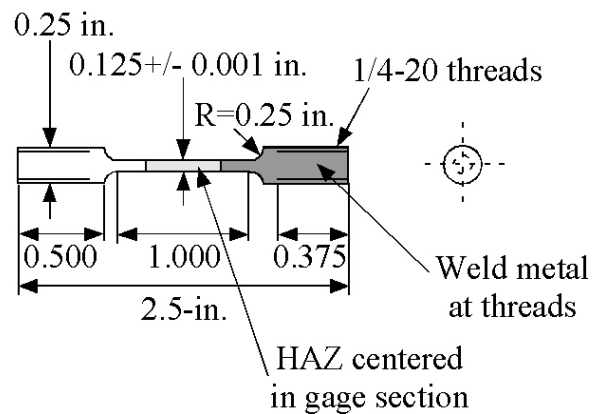
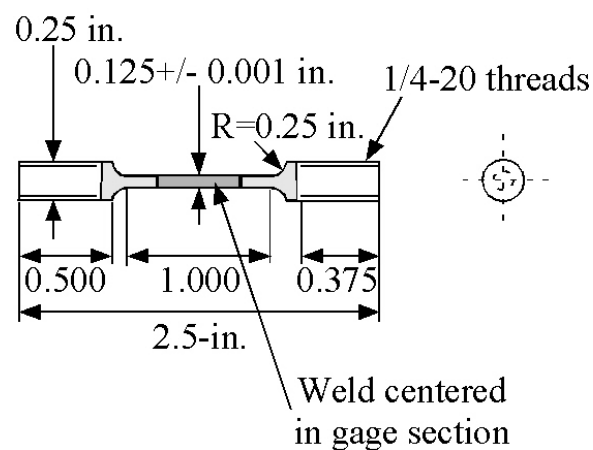
a) Base metal specimen.

b) HAZ specimen.

c) Weld metal specimen.

Figure 4. Drawings showing three difference types of specimens incorporating the base metal, HAZ, and weld.

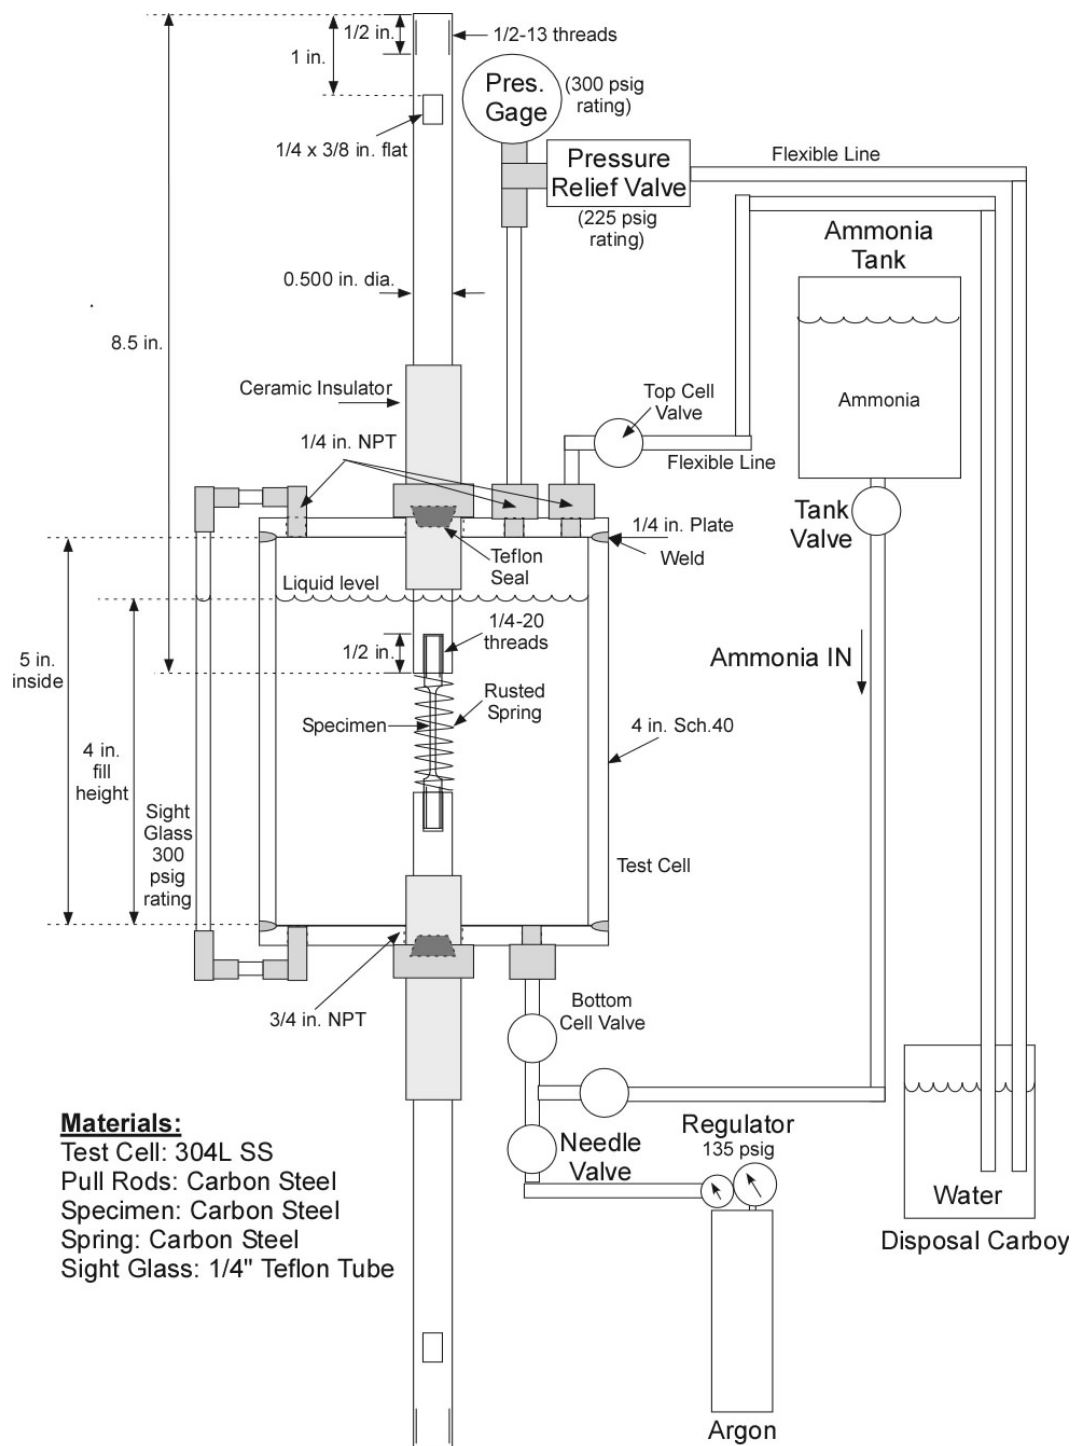
Figure 5. Diagram of test cell.

A diagram of the test cell is shown in Figure 5. The specimens had a machined surface rather than “as welded.” To simulate the presence of corrosion products on the tank’s surface, a pre-corroded coil spring was placed around each machined specimen. The carbon steel specimen with the spring was then threaded into carbon steel pull rods that inserted in a stainless autoclave through Teflon sliding pressure seals. The pull rods were connected to the SSR machine to apply the tensile load. The pull rod assembly with the specimen and spring was electrically isolated from the test cell. Ports for filling and emptying the autoclave and a pressure gage and pressure relief valve were incorporated in the autoclave.

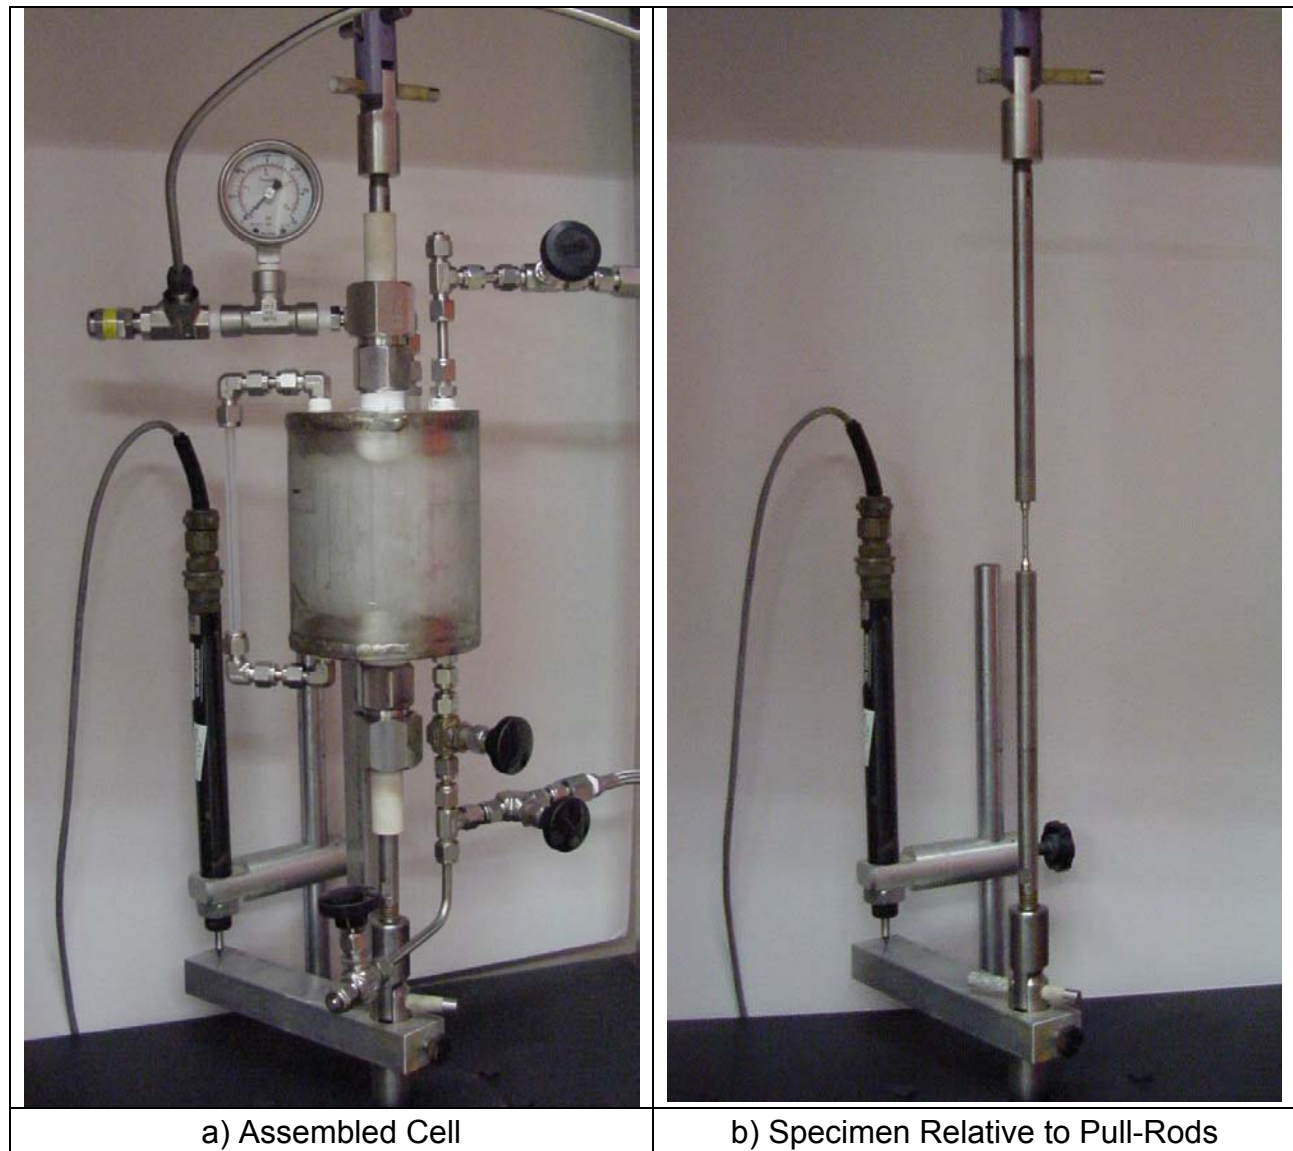
Figure 6. Photographs of cell assembly and a specimen shown positioned in SSR machine, but without the cell.

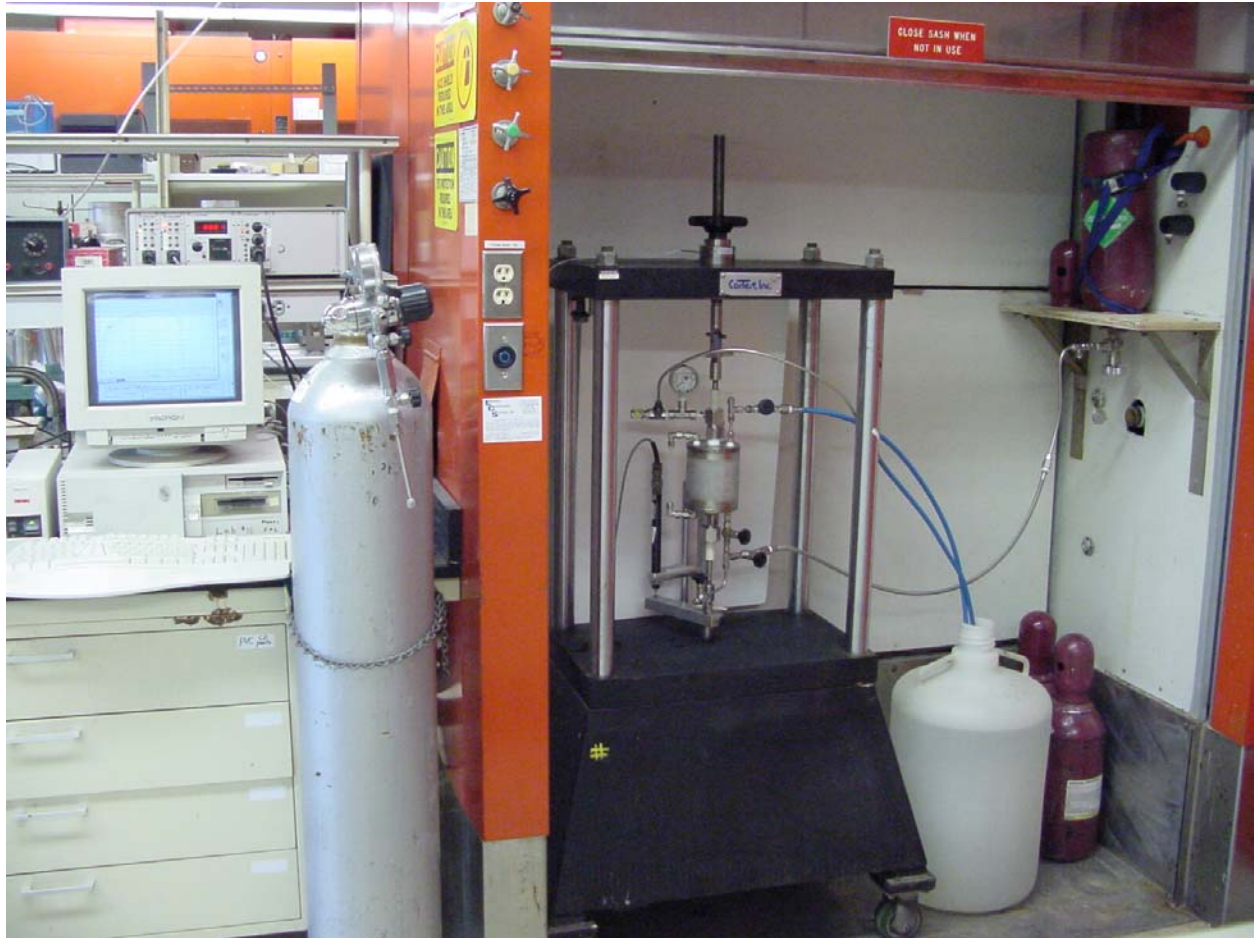
Figure 7. Test setup in SSR machine and associated computer control system.

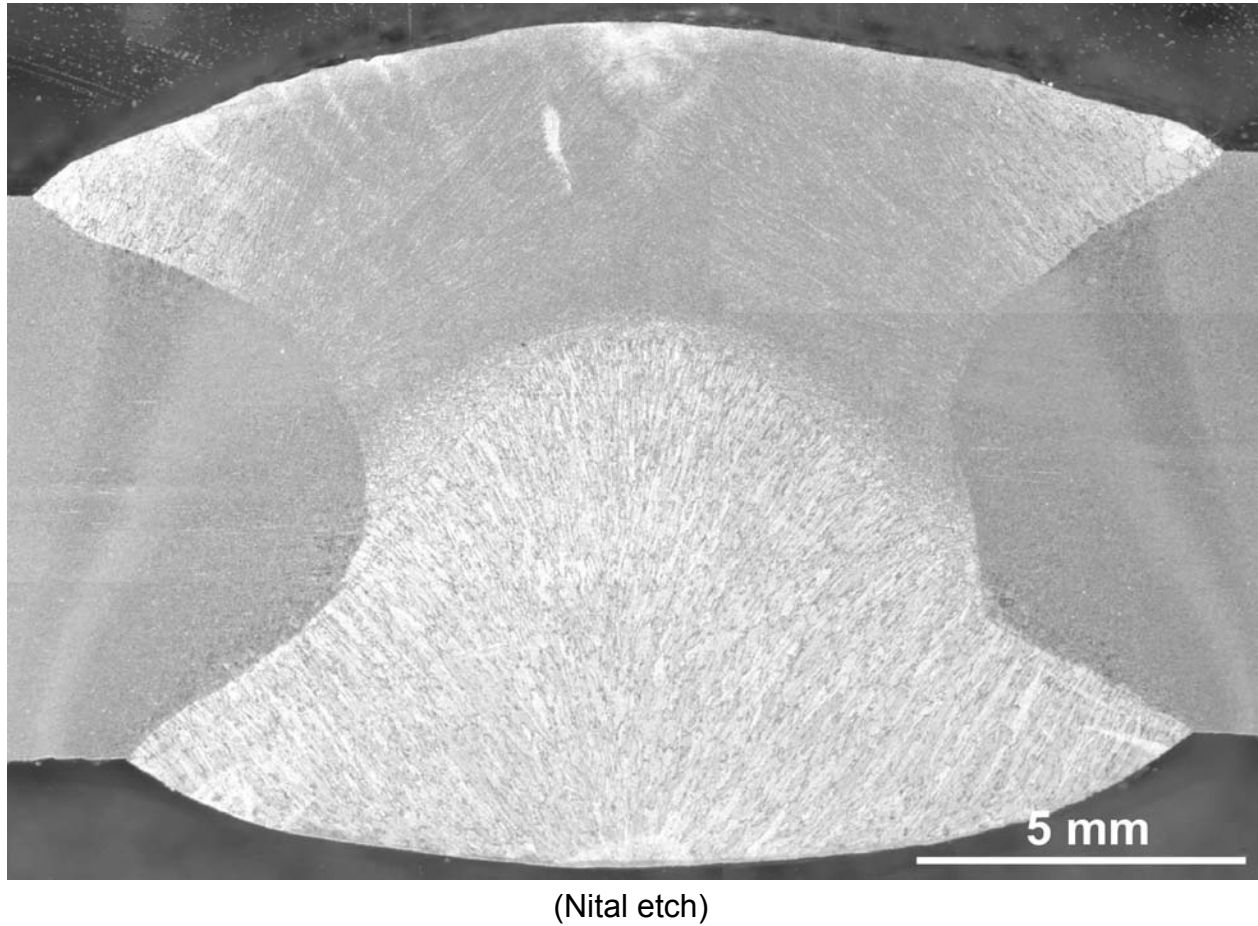
Figure 8. Photomicrograph of cross-section of weld.

A metallographic cross-section through the weld was prepared to document its appearance and microstructure in the as-received condition. The cross-section was prepared using standard metallographic procedures, consisting of increasingly fine grinding steps on SiC abrasive paper, with a final polish of 3 μm diamond paste. A Nital etchant was used to reveal the microstructure. The weld was examined at 25X magnification using a Nikon SMZ800 Zoom Stereomicroscope.

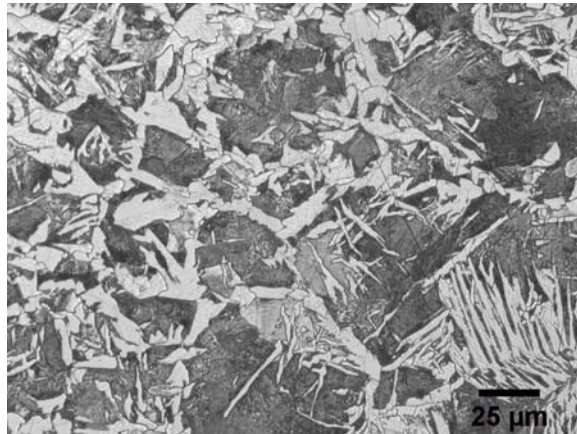
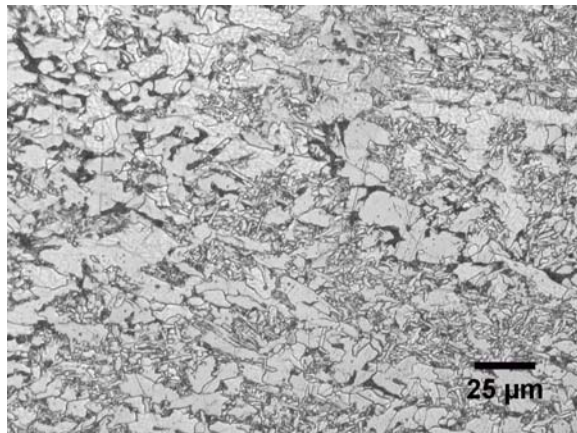
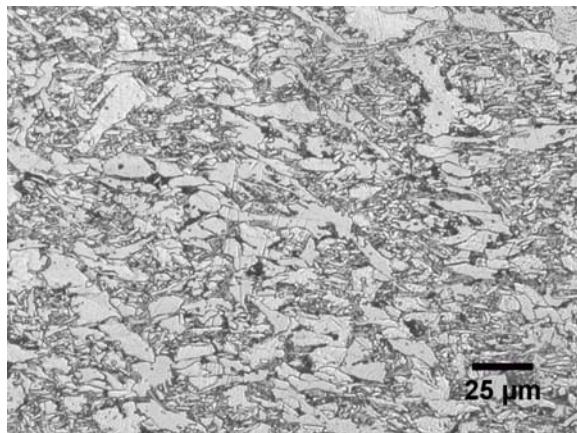
Figure 9. Optical photomicrographs showing grain structures visible at different locations in the plate (Nital etch).

Figure 9. Optical photomicrographs showing grain structures
(continued) visible at different locations in the plate. (Nital etch)

Examples of the microstructures present at different locations near and in the weld are shown in Figure 9. These photomicrographs were taken from Specimen 2. The plate's base metal (a) had a banded microstructure of ferrite (light constituent) and pearlite (dark constituent). Banding results from manufacturing the steel plate when it is hot-rolled to its final shape. Qualitatively, the amount of pearlite appears consistent with approximately 0.3% C in the carbon steel. The HAZ near the base metal (b) also reveals the banded structure, and ferrite and pearlite are visible. However, the grain size is much finer in this area of the HAZ than in the base metal, indicating that normalizing has taken place. The center of the HAZ (c) contains larger grains, and the ferrite and pearlite are not banded. This microstructure is consistent with grain growth following normalizing (austenitizing) as a result of heating. The HAZ near the weld (d) showed large pearlite grains with grain boundary ferrite along prior austenite grain boundaries and Widmanstätten ferrite (plate-like) within the pearlite grains. Again, this is a microstructure caused by heating. The weld fusion metal near the HAZ (e) and the weld fusion metal at the weld center (f) both have a solidification microstructure with fine pearlite (dark) in a matrix of ferrite (light). The grains are elongated along the direction of maximum heat flux, which occurred during weld solidification.

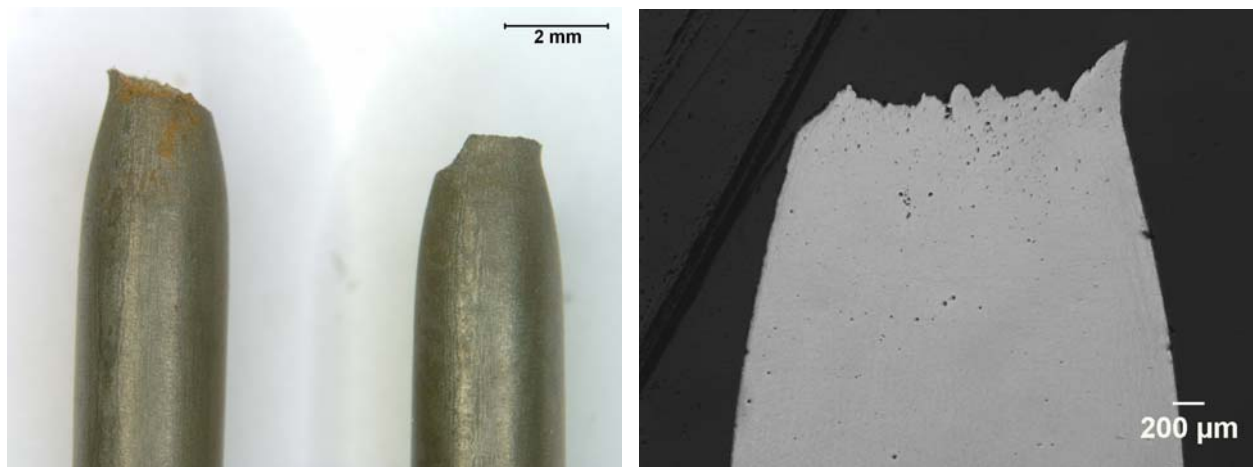
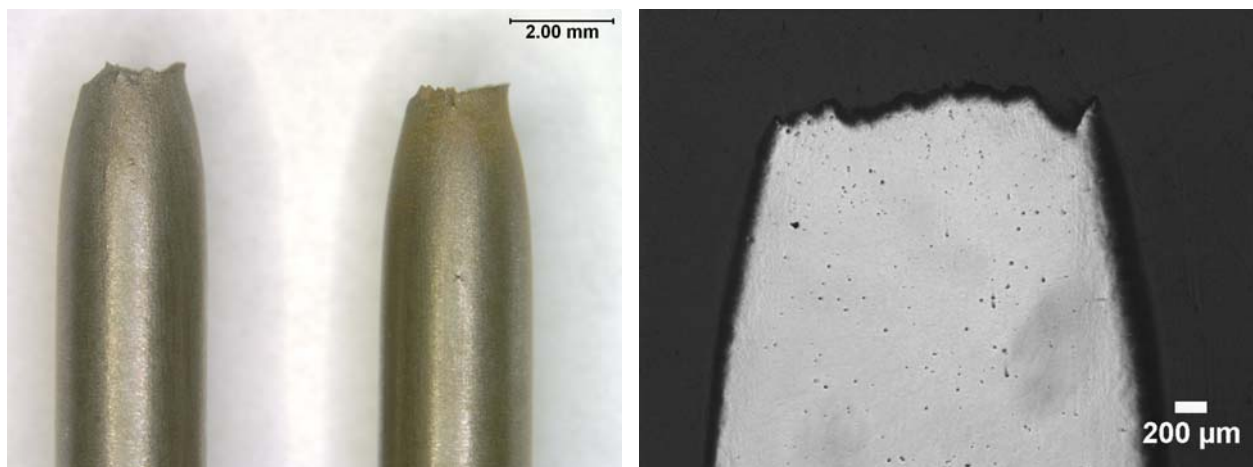
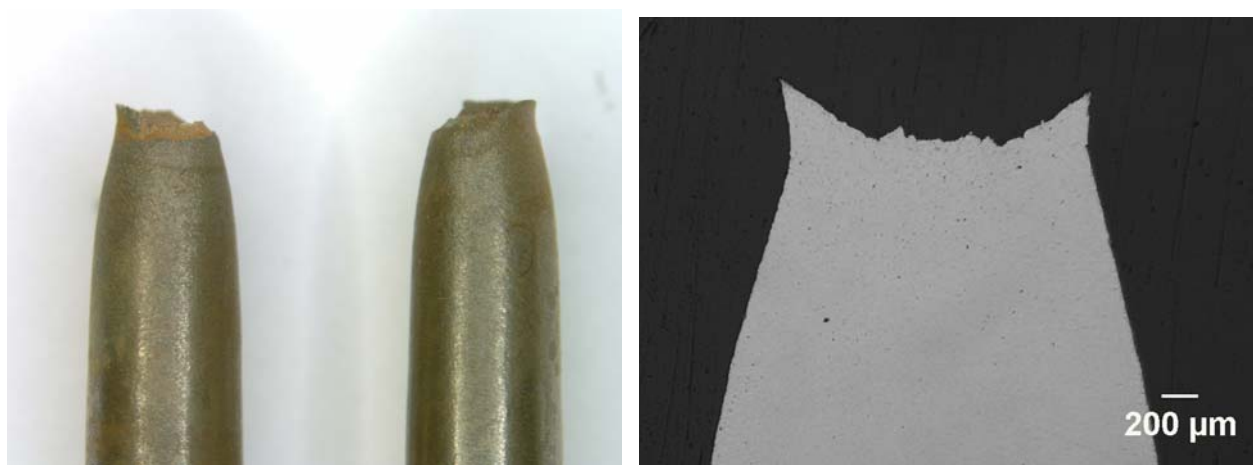
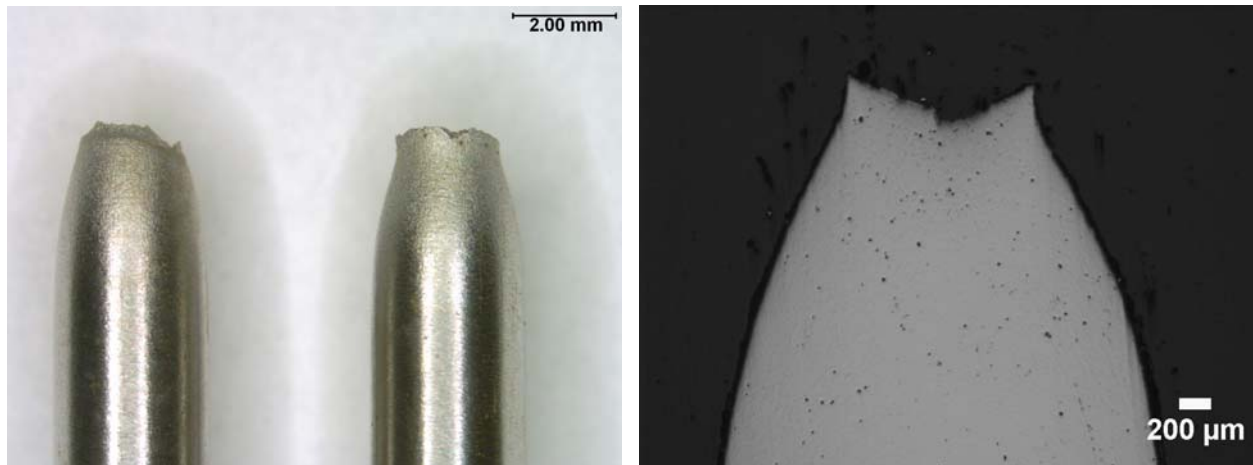
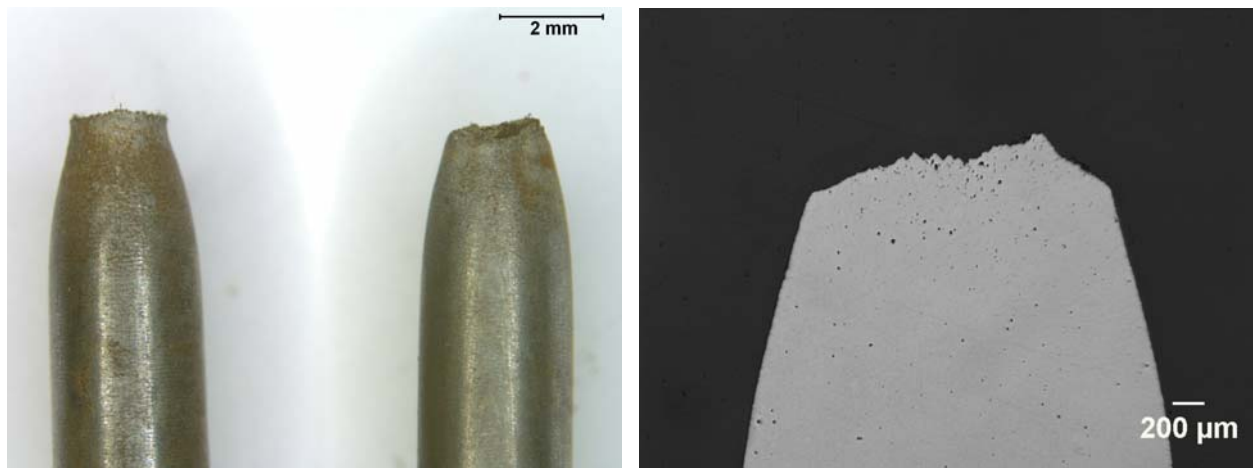
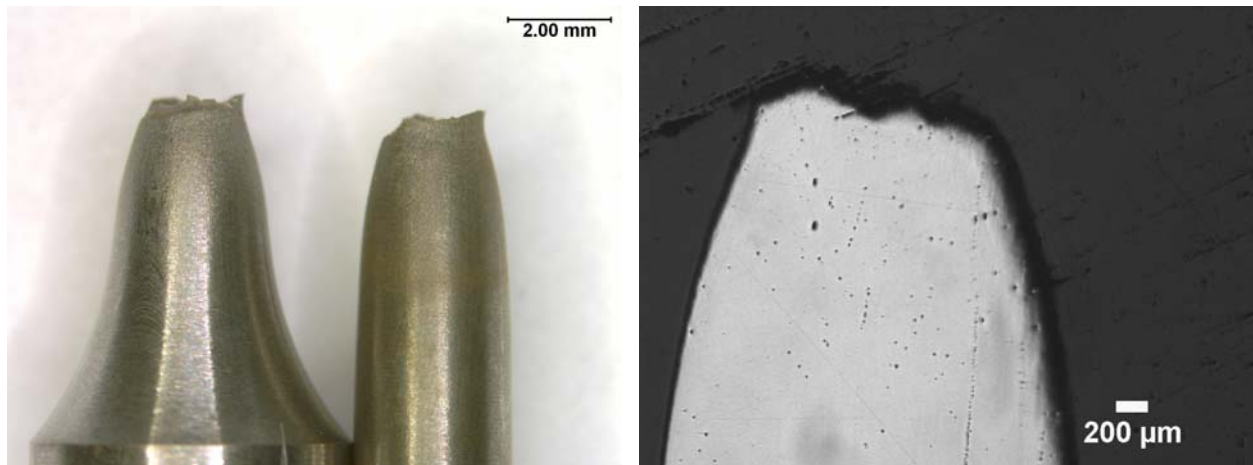
Figure 11. Tests in anhydrous ammonia – photographs of the fractured gage sections of the various specimens, and photomicrographs showing the respective fractured tips in longitudinal cross-sections, as-polished.

Figures 11, 12, and 13 show photographs of the gage sections of the fractured specimens alongside photomicrographs of the longitudinal cross-sections of the respective fracture tips. All specimens failed in the gage section, and all had significant necking to form cup and cone fracture appearance, which is indicative of overall ductile failure. With the exception of the shiny metallic specimens from Test 15 (base metal – ammonia) and Test 14 and 17 (base metal and weld metal in ammonia + 2% $\text{Ca}(\text{NO}_3)_2$), the specimens tested in anhydrous ammonia and anhydrous ammonia + 2% calcium

nitrate had a gray/black surface scale and scattered orange corrosion spots. The spots appeared to have formed as flash-rust immediately after removing the specimens from the test cell. All specimens tested in solutions containing N-Serve® retained a metallic luster after the test.

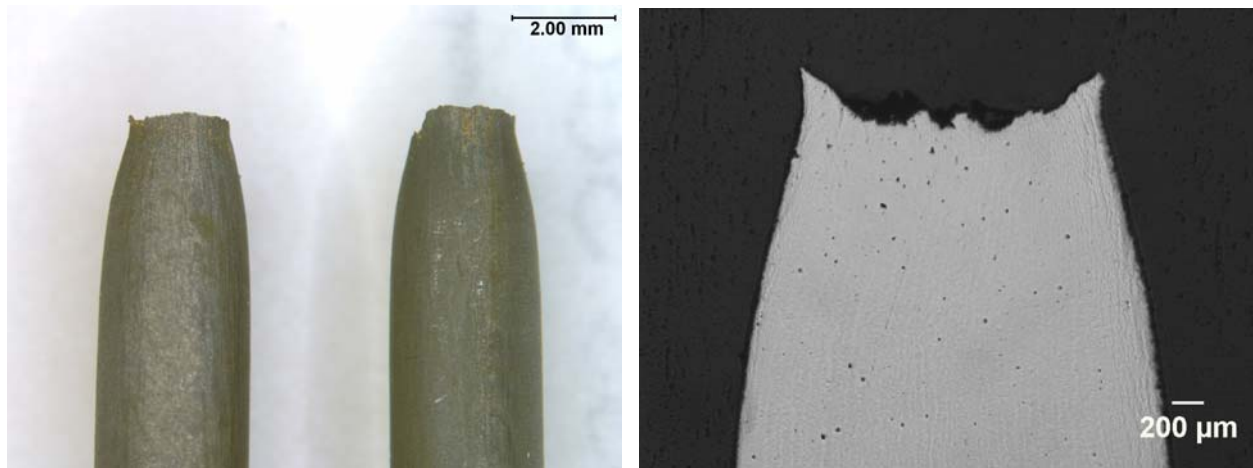
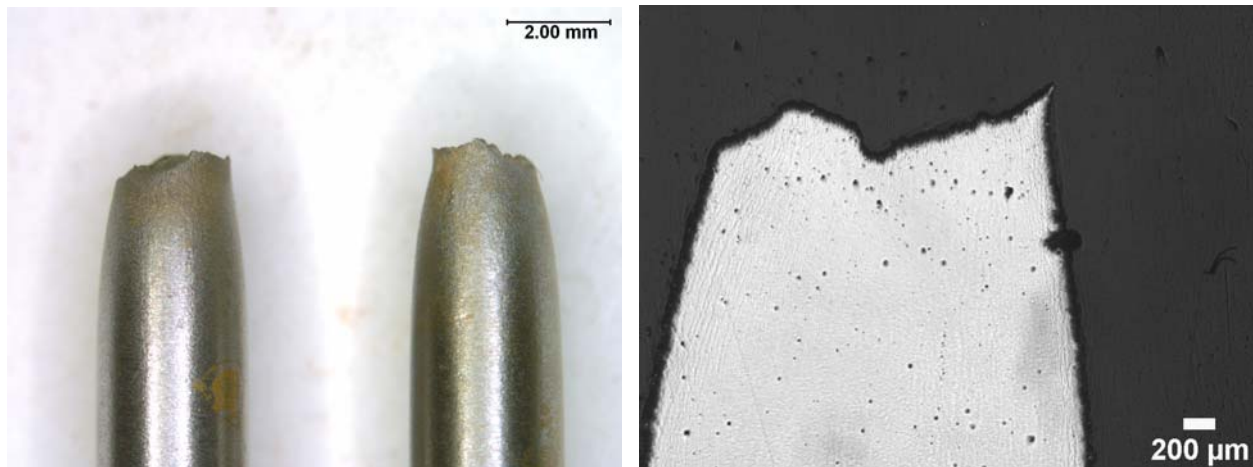
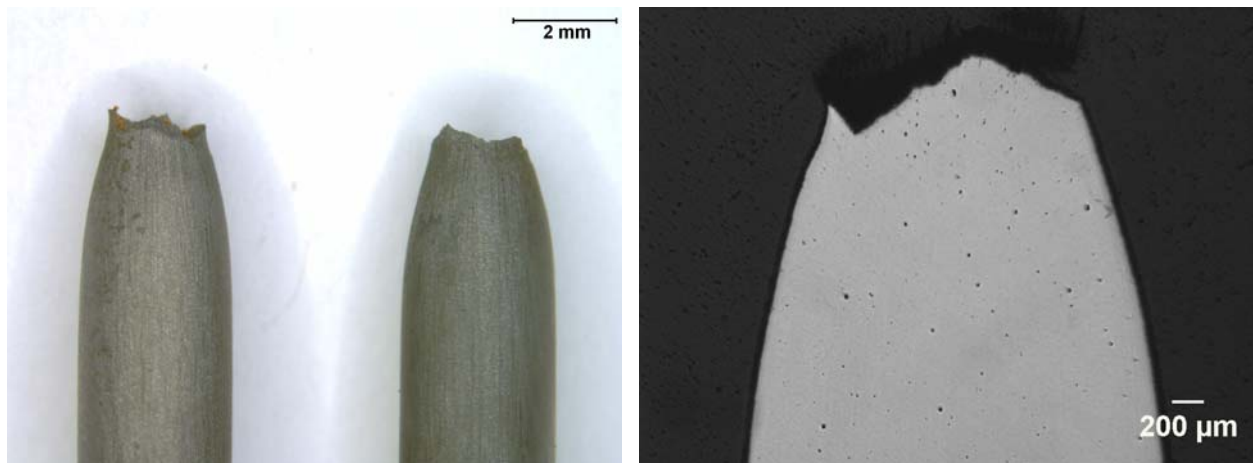
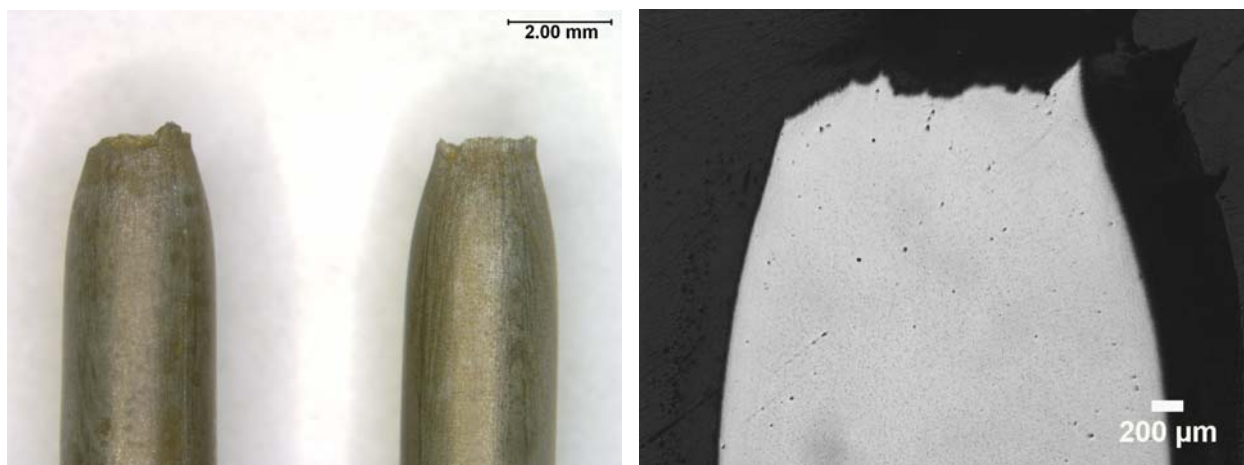
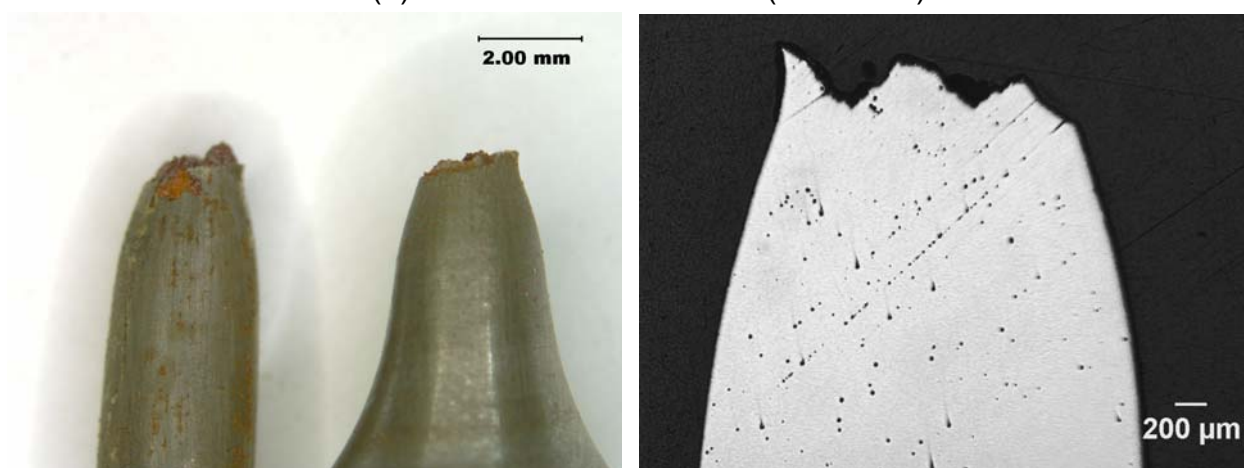
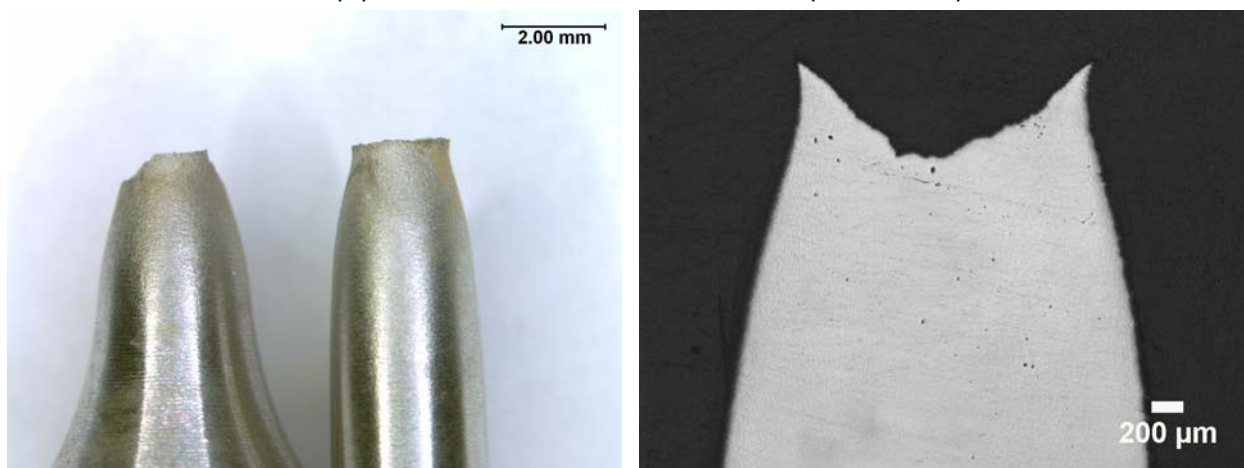
Figure 12. Tests in anhydrous ammonia with 2% $\text{Ca}(\text{NO}_3)_2$ – photographs of the fractured gage sections of the various specimens, and photomicrographs showing the respective fractured tips in longitudinal cross-sections, as-polished.

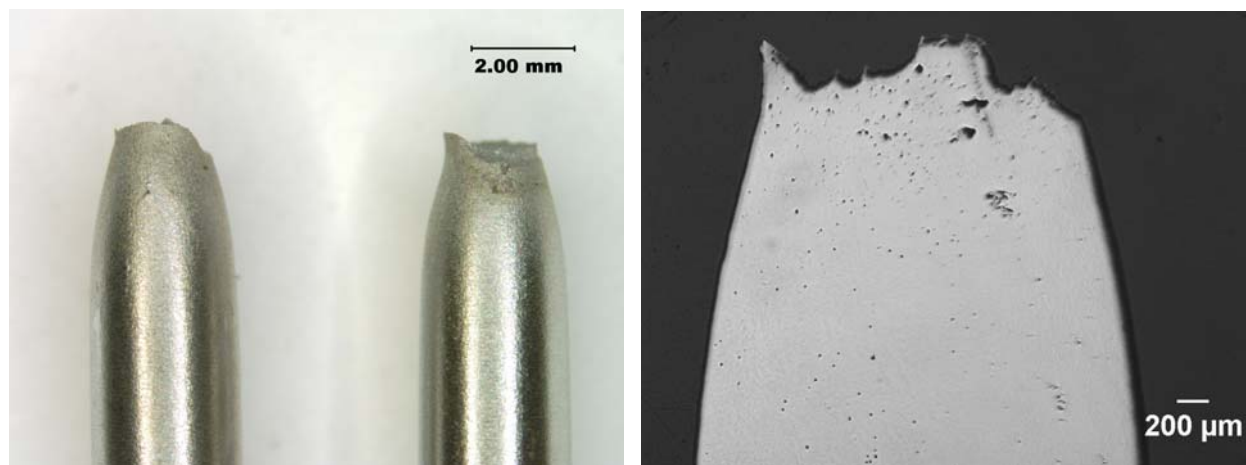
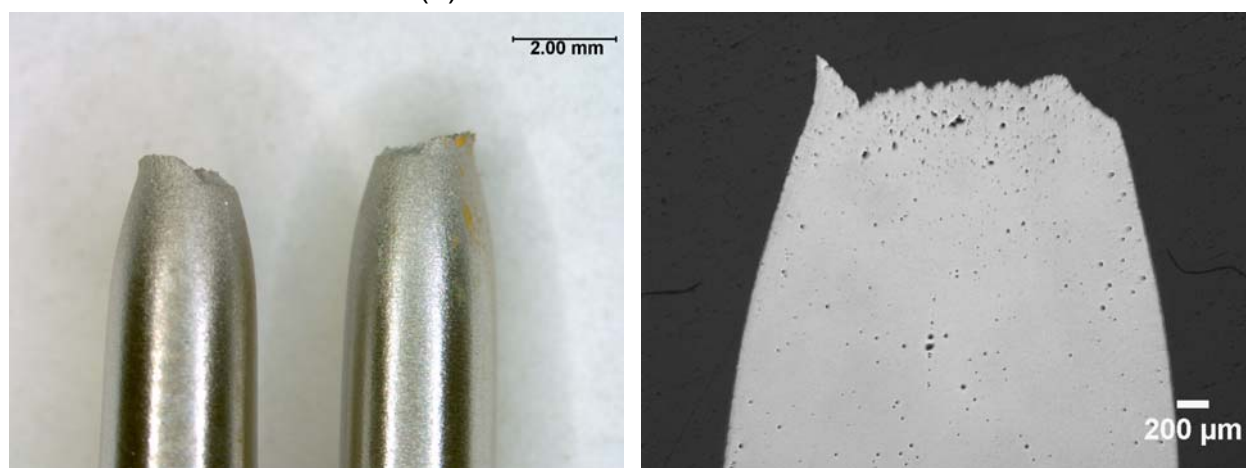
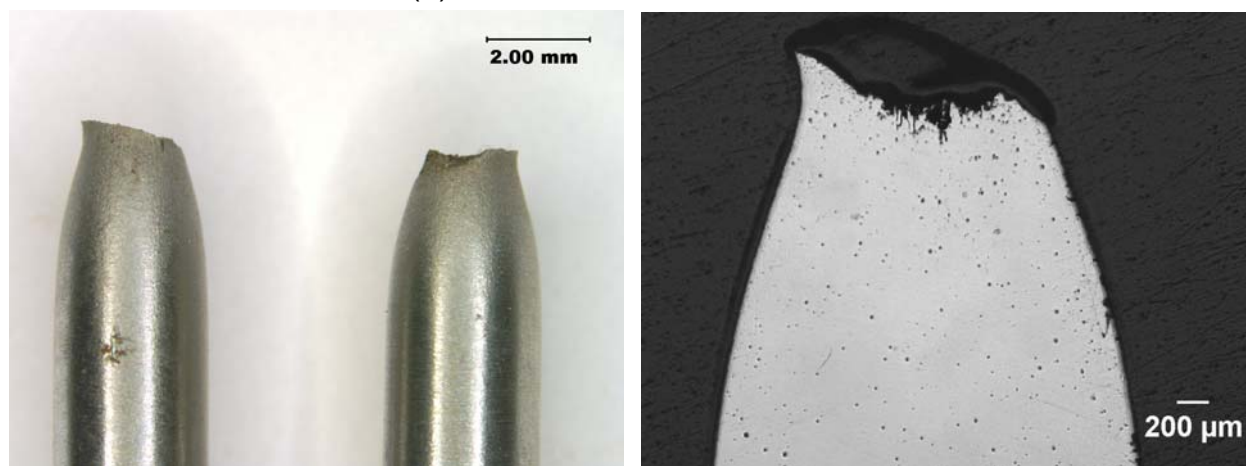
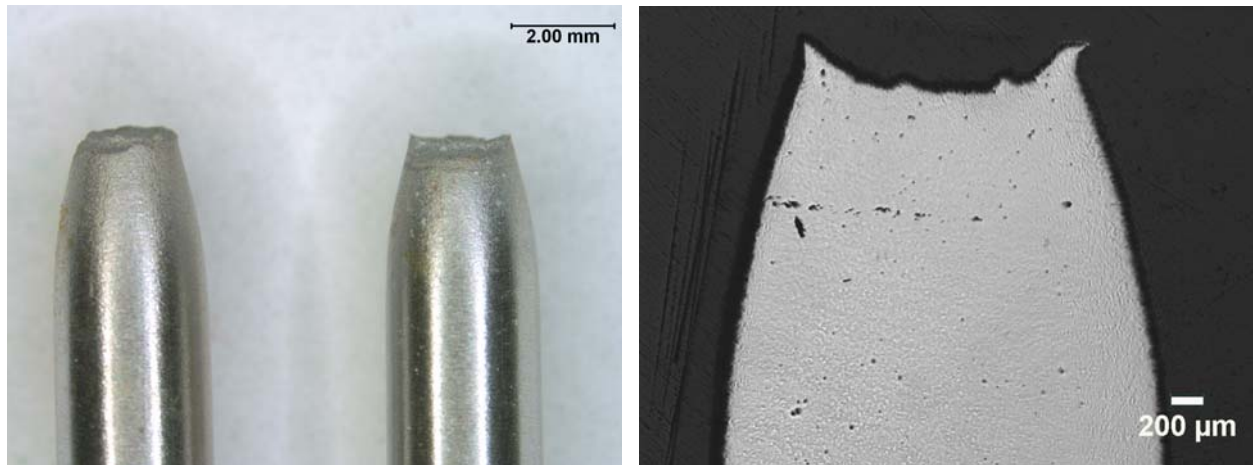
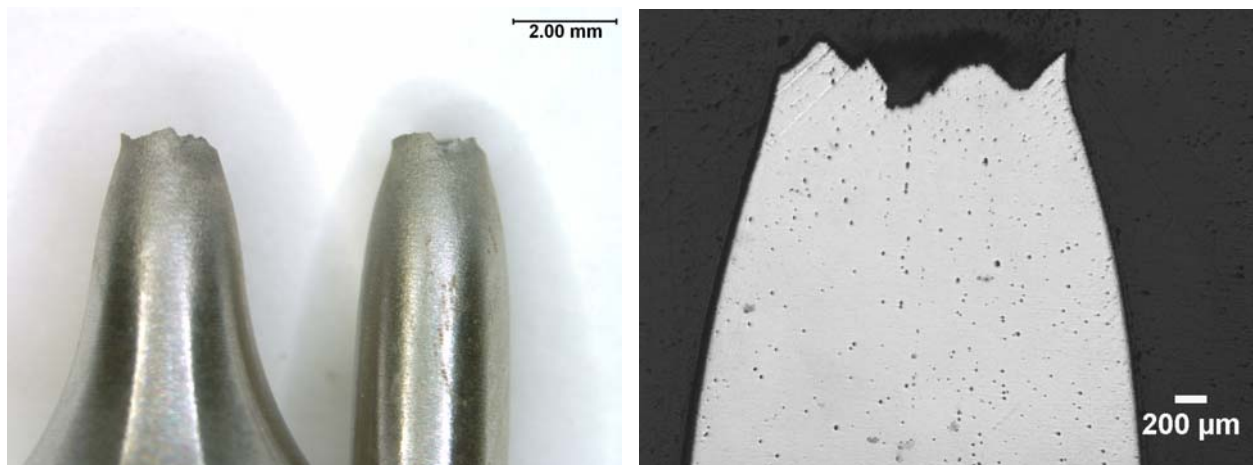
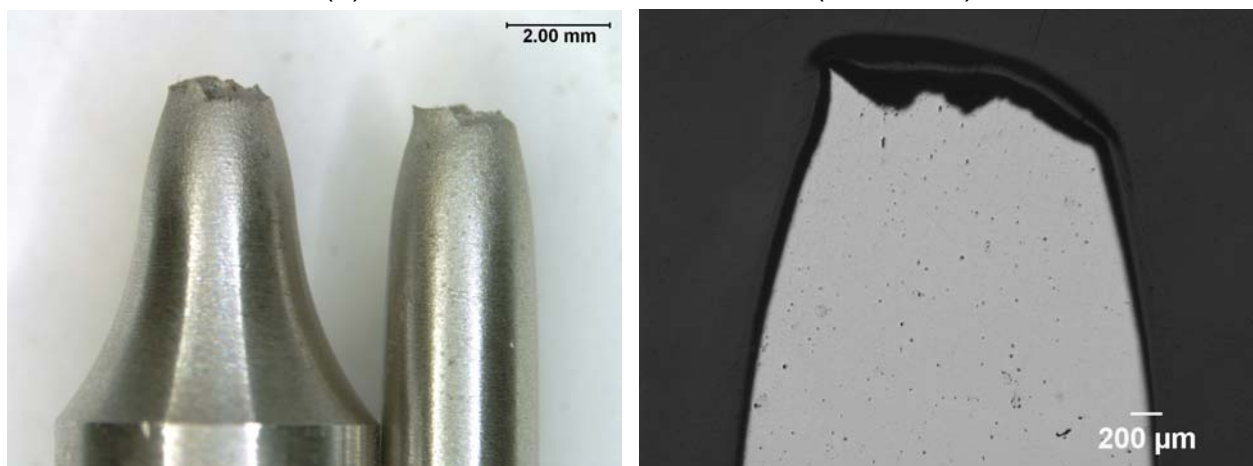
Figure 13. Tests in anhydrous ammonia with 2% $\text{Ca}(\text{NO}_3)_2$, and N-Serve® – photographs of the fractured gage sections of the various specimens, and photomicrographs showing the respective fractured tips in longitudinal cross-sections, as-polished.

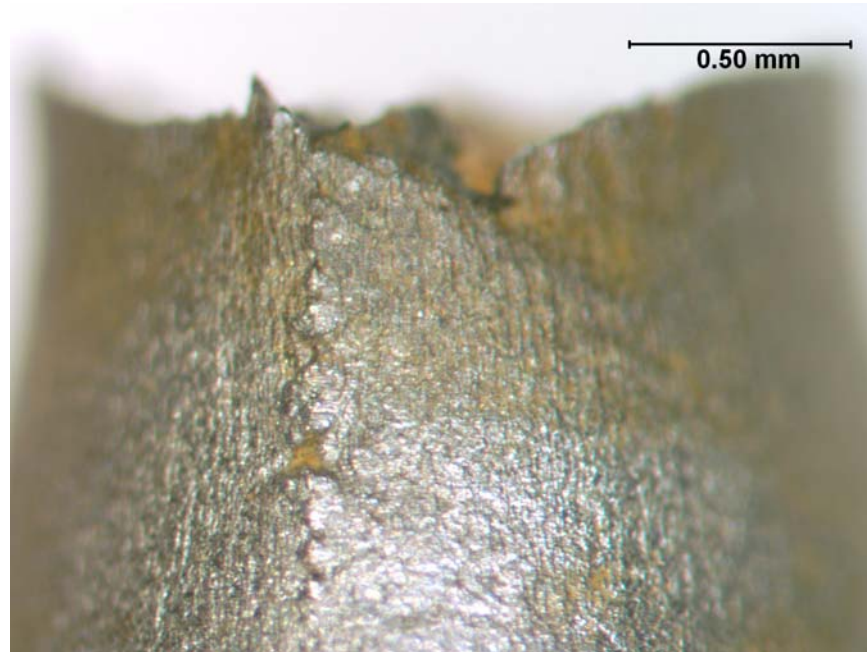
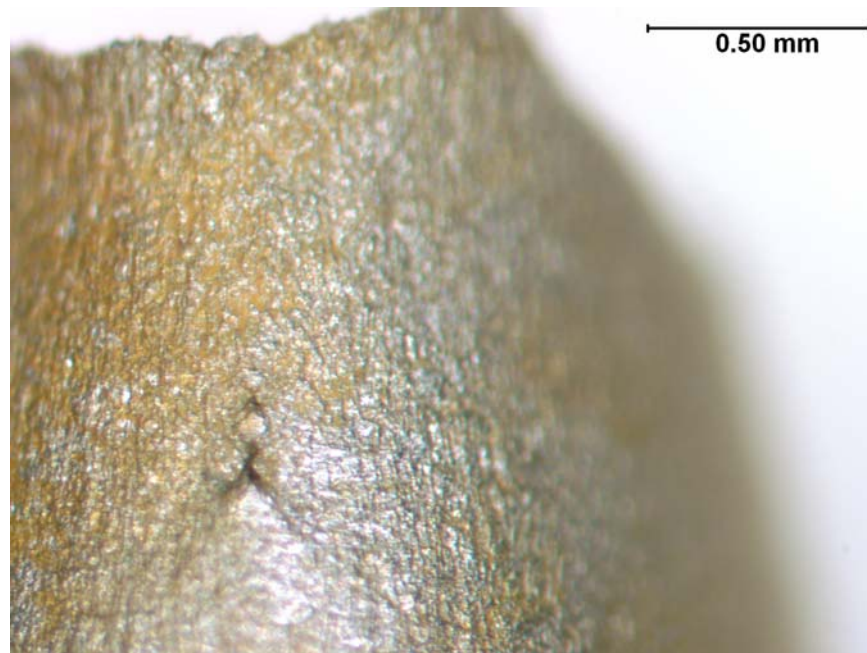
Figure 14. Stereo-photomicrographs of gage section near fracture surface of specimen from Test 14 showing small surface fissures.

At higher magnifications, small surface fissures were revealed on the specimens from Tests 14, 17, and 12, as shown in Figures 14, 15, and 16, respectively. For these specimens, the longitudinal cross-sections were prepared by cutting through these features. For all other specimens, no notable surface features were visible and a random longitudinal cross-section was made halfway through the gage thickness.
